INFRARED TECHNOLOGY SERVICES

Infrared Inspection Report

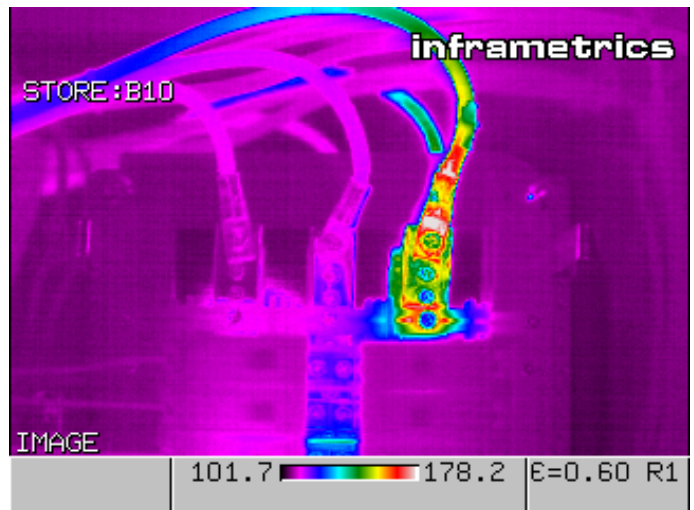
Anomaly Number:	3		
Severity Rating:	15	Inspection Date:	8/30/2010
		Time:	1426
Anomaly Location:	Floor 8 Electrical Room, Breaker Panel ELB2, main leads		
Description:	Right lug connection, appears to be squeeze-on connection

Anomaly Target Temperature:	185
Reference Temperature:	108
Ambient Temperature:	80

Rise Above Ambient:	105
Rise Above Reference:	77

Recommendation:	Corrective measures should be taken IMMEDIATELY.
-----------------	--

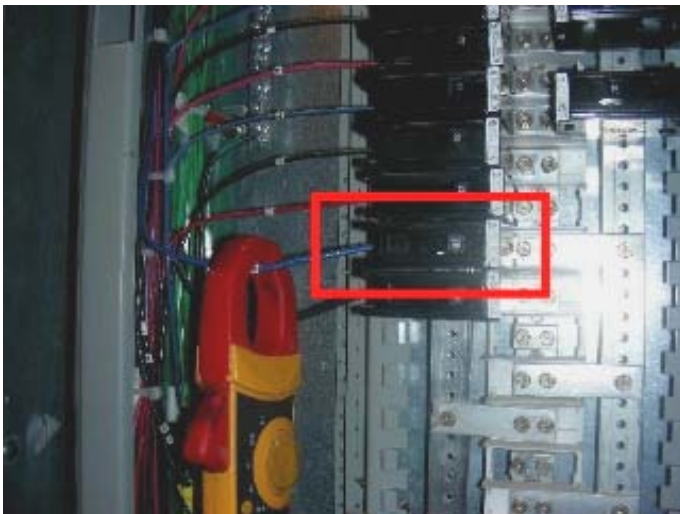
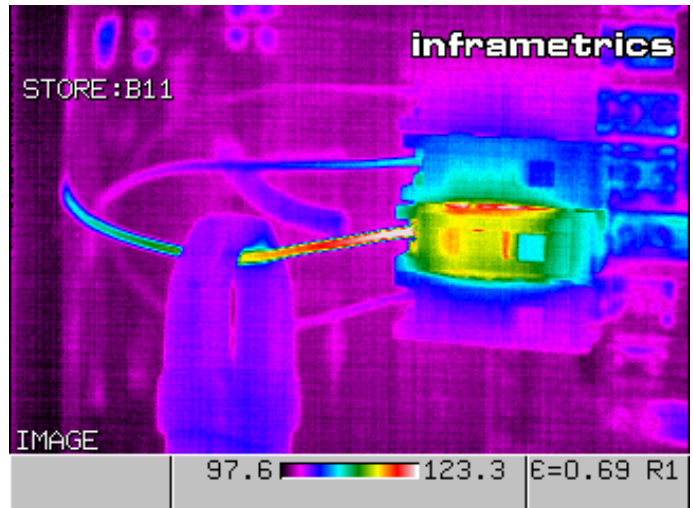
Anomaly Number:	4	Inspection Date:	8/30/2010	Time:	1444
Severity Rating:	9	Anomaly Location: Floor 4, Breaker Panel L4C, breaker #29 (AA Fixtures High Ceiling)			
Description:	Load on breaker is greater than 80% 18 amps on 20 amp breaker

Anomaly Target Temperature:	129
Reference Temperature:	
Ambient Temperature:	83

Rise Above Ambient:	46
Rise Above Reference:

Recommendation:	Corrective measures should be taken at next scheduled maintenance period.
-----------------	---

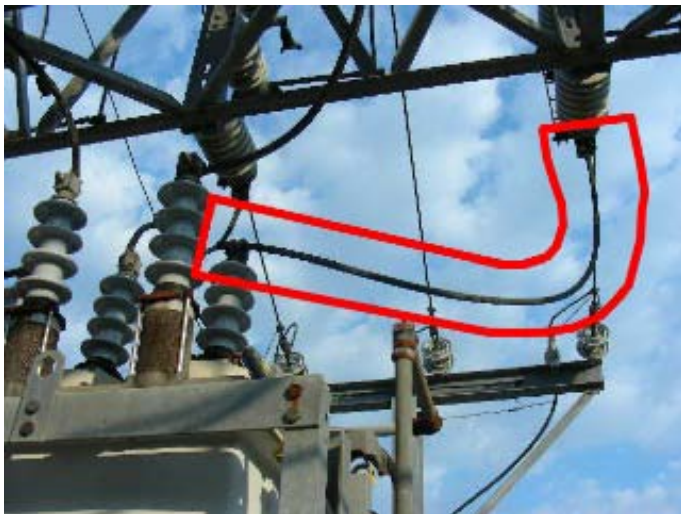
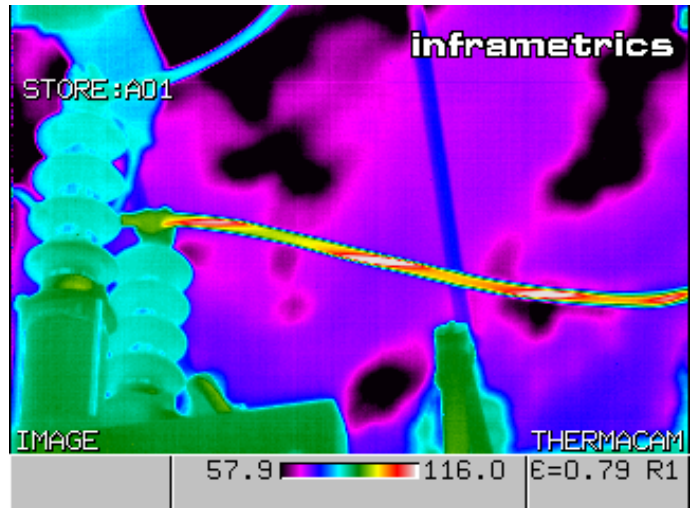
Anomaly Number:	1	Inspection Date:	8/24/2010	Time:	0811
Severity Rating:	10	Anomaly Location: Black Ankle Substation, Circuit 3 Breaker, load side north phase			
Description:	Conductor from bushing to bottom of switch, appears to be bad conductor

Anomaly Target Temperature:	114
Reference Temperature:	80
Ambient Temperature:	80

Rise Above Ambient:	34
Rise Above Reference:	34

Recommendation: Corrective measures should be taken on a Priority basis.

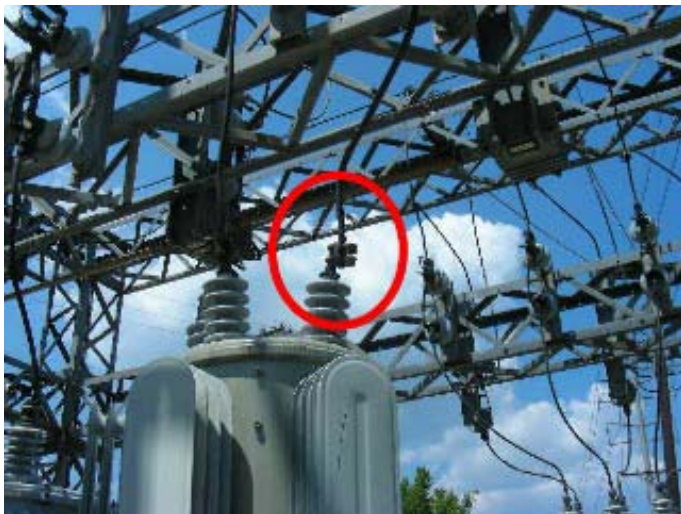
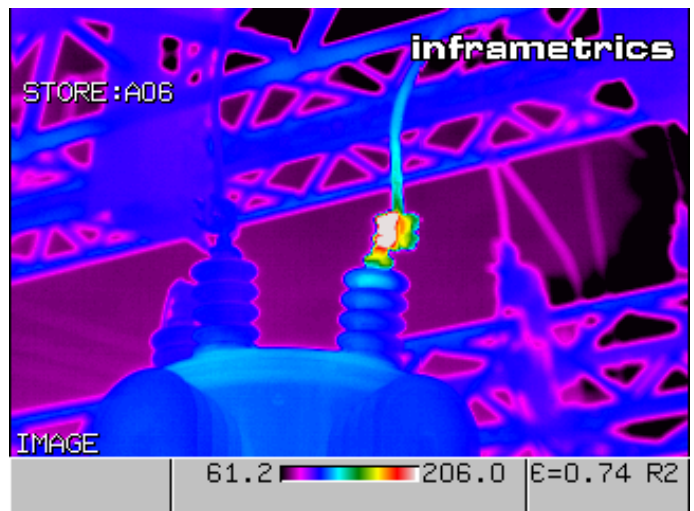
Anomaly Number:	5	Inspection Date:	8/24/2010	Time:	1411
Severity Rating:	15	Anomaly Location: Temple II Substation, east phase regulator			
Description:	Source bushing connection

Anomaly Target Temperature:	257
Reference Temperature:	107
Ambient Temperature:	96

Rise Above Ambient:	161
Rise Above Reference:	150

Recommendation: Corrective measures should be taken IMMEDIATELY.

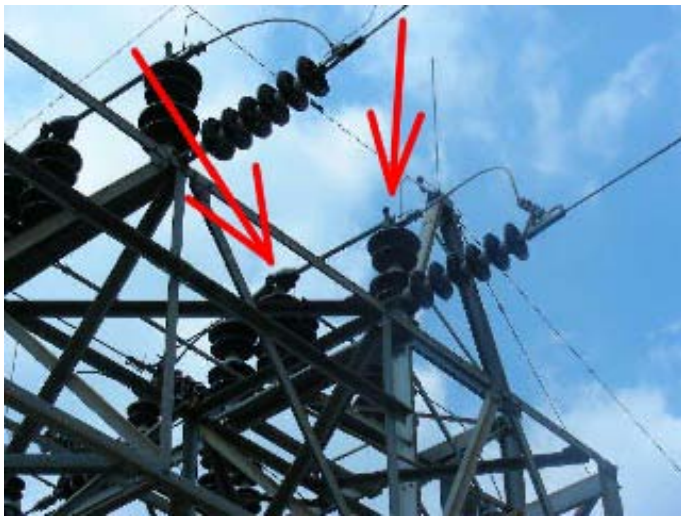
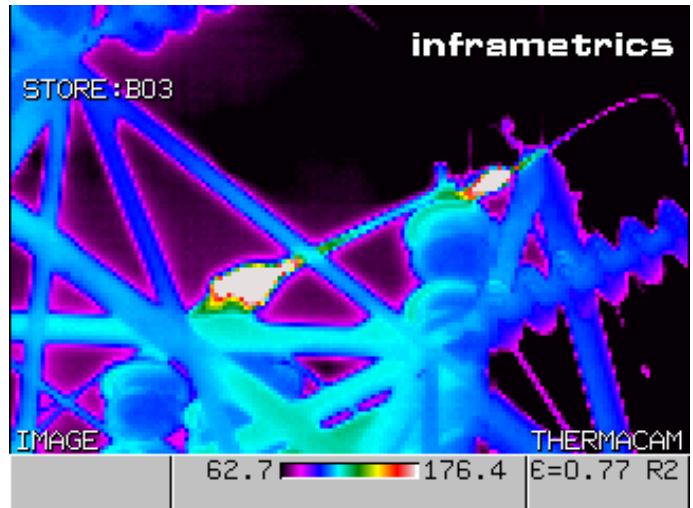
Anomaly Number:	15		
Severity Rating:	15	Inspection Date:	8/25/2010
		Time:	1527
Anomaly Location:	Timpson Substation, transmission switch 6925 – north phase		
Description:	Hot at pivot knuckle connection and jaw end of switch arm

Anomaly Target Temperature:	247
Reference Temperature:	114
Ambient Temperature:	95

Rise Above Ambient:	152
Rise Above Reference:	133

Recommendation:	Corrective measures should be taken
-----------------	-------------------------------------

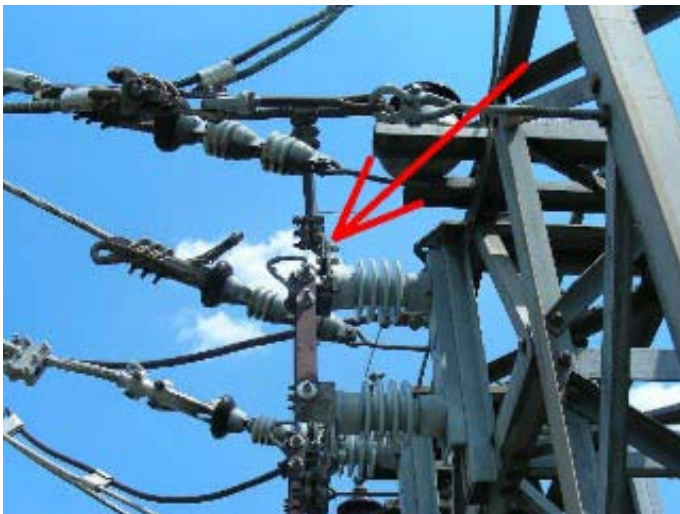
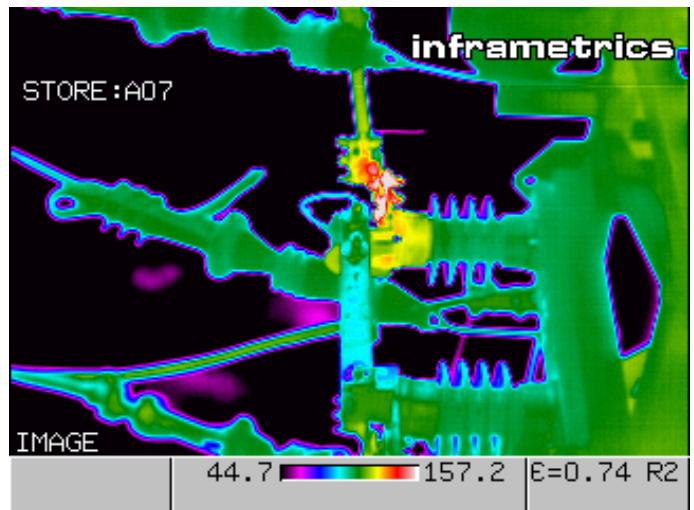
Anomaly Number:	6		
Severity Rating:	15	Inspection Date:	8/24/2010
		Time:	1428
Anomaly Location:	Temple I Substation, Load side - west phase switch		
Description:	4-bolt pad connector to top of switch

Anomaly Target Temperature:	174
Reference Temperature:	117
Ambient Temperature:	96

Rise Above Ambient:	78
Rise Above Reference:	57

Recommendation:	Corrective measures should be taken IMMEDIATELY.
-----------------	--
